# BUILDING AUDIT REPORT

**OWEN SOUND POLICE SERVICE** 922 2<sup>ND</sup> AVENUE WEST, OWEN SOUND, ONTARIO

Our Project No.: 240194

Date: June 30, 2023

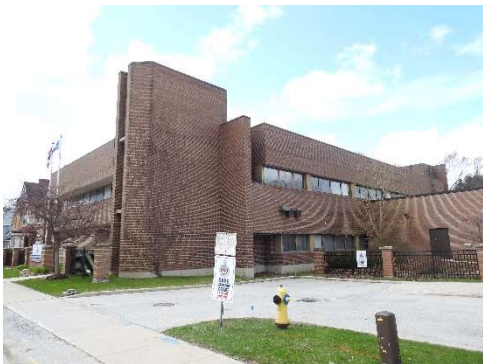
### **1.1 PROPERTY DESCRIPTION**

Constructed in 1969/1970, the two-storey building, designed by Gordon S. Adamson and Associates, Toronto, served as the headquarters for CIAG Insurance. Purchased in the late 1990's, the building was renovated in 1999, with design by Carruthers Shaw and Partners Limited as the new Central Emergency Response Bureau for the City of Owen Sound. Further renovations in 2008 to 2009 to the 2<sup>nd</sup> floor for the Police Services, with design was by G.M. Diemert Architect Inc., Owen Sound. An addition to the north was constructed in 2010 for a Sally Port and holding cells. The main floor

layout of the building includes the newer Sally Port, interview rooms, storage and holding cells, dispatch area (to be relocated to 2<sup>nd</sup> floor), offices, parade room, meeting rooms, vehicle storage/examination room, lunch room, washrooms, and main service rooms. The 2<sup>nd</sup> floor has various offices, administrative areas, meeting rooms, locker rooms, service rooms, weight room (future), and emergency training room (future). The Penthouse Mechanical Room includes the main air handling unit for the building. The main entrance is accessed from at the east elevation, with staff entrance at the west elevation. On site parking for visitors and staff are

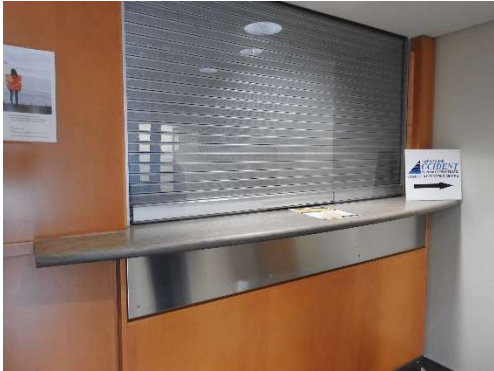
### 3.1 Summary of Design

The two-storey building layout has offices on both floors with the Sally Port and holding cells to the northwest. Parking is located at the north and west sides of the building with main entrance on the east side.

The building was constructed in 1969/1970 and has had no significant improvements to remove barriers. The current provisions include dedicated parking, automated main entry doors, main floor public washroom, and elevator.
